# PROPERTY INSPECTION REPORT

**Single Family Residence  
xxxxxxx Ct.  
Encino, California**

Monday September 20, 2015

**Preferred Home Inspection, LLC**

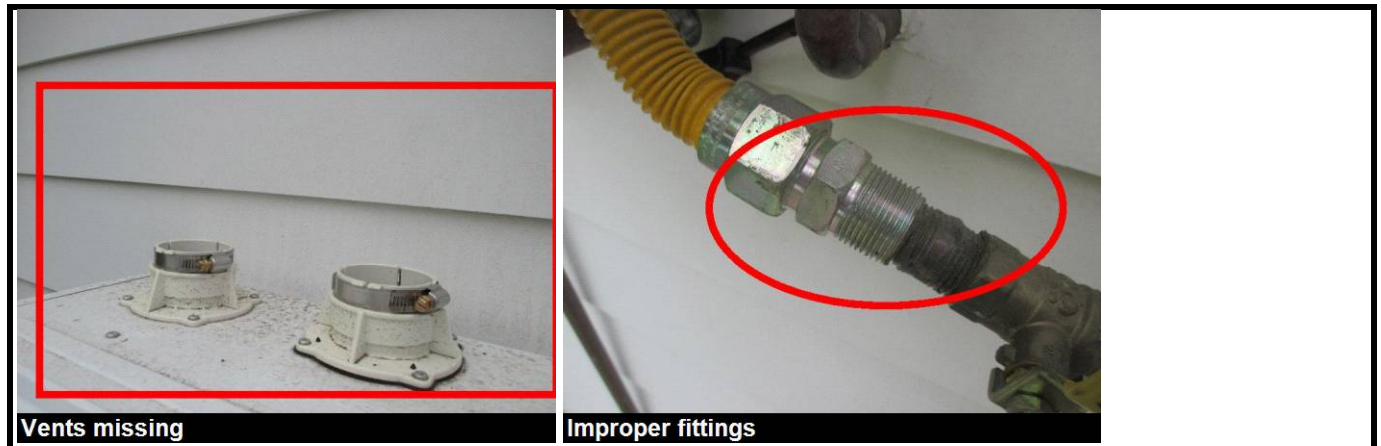
Water heater is missing vent pipes. Installation needs to be completed.

Gas flex connector at water heater has improperly fitting configuration. Installation should be corrected.

**Vents missing****Improper fittings**

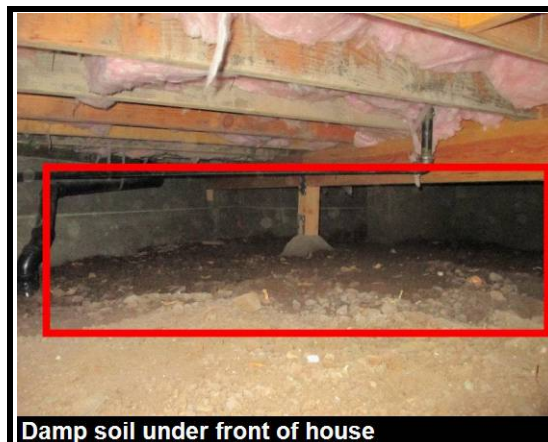
Damp soil was noted under portion of sub area along front of house, evidently due to faulty grade / drainage condition at front. Entry point needs to be isolated and corrected. Water also has a tendency to enter crawlspace access openings at rear of the house. Step should be taken to prevent this from occurring.

Damp soil under front of house

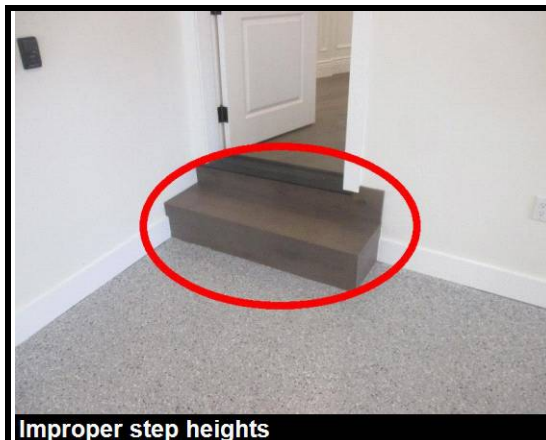
Stair steps (risers) are required to be uniform in height within 3/8". Riser height differentials in excess of 3/8" can pose an increased trip hazard. Irregular riser height(s) were noted at

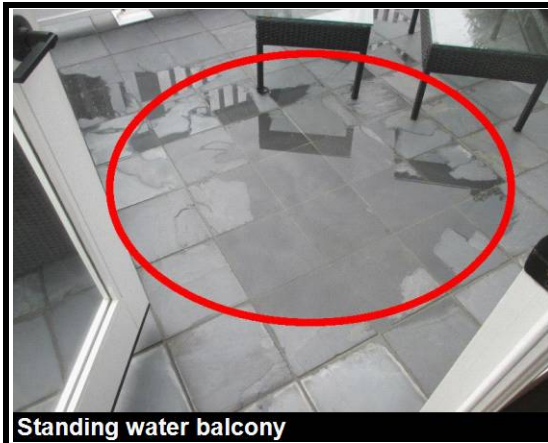
a. Rear balcony off loft has insufficient slope for drainage. Water stands on balcony surface.

b. Balcony surface has only surface drains and no overflow drain(s) at master bedroom front balcony. Building standards require supplemental overflow drains in addition to primary drains. As is, ensure primary drain is maintained / kept clear.

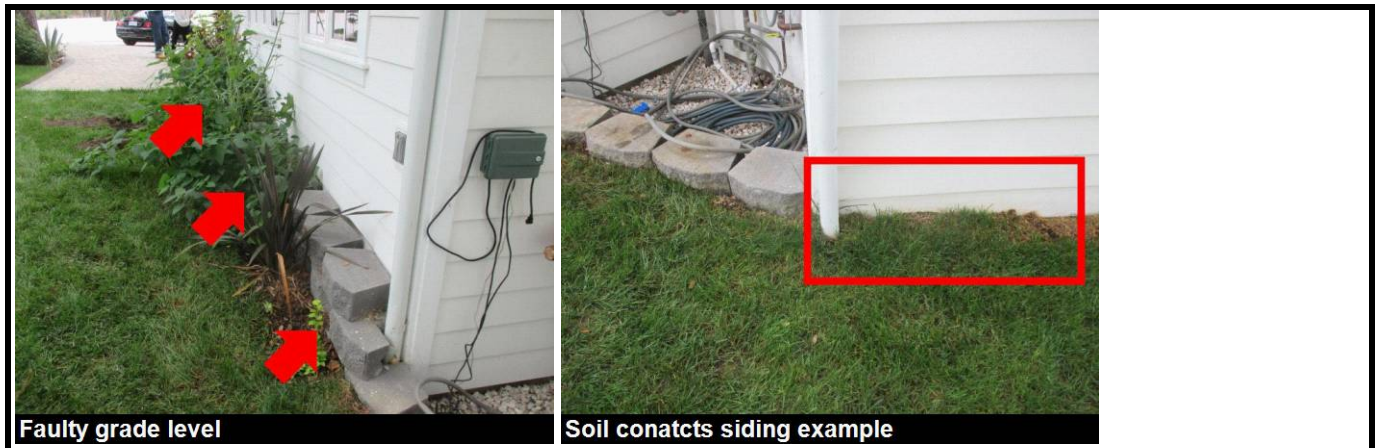
- a. Faulty grade level is condition where soil is built up too high against house above wood siding or sill line... Faulty grade level exists along portion of house along front outside family room which also may be allowing water intrusion into sub area, as noted on Foundation page.. Faulty grade level needs to be addressed. An insulator curb appears to be necessary redress, though a foundation / drainage contractor should evaluate to verify and advise on proper method of redress.

- b. Soil should not contact wood as wood decay may occur. Earth to wood contact was noted (soil too high contacting siding) at areas at rear and south sides of house.) Grade level needs to be corrected where contact occurs.

- c. Siding is embedded in hard surfaces at patio. Properly, an air gap should exist between siding base and ground. This can increase potential for wood decay. Condition may prove uneventful, though siding should be monitored at areas where this occurs.

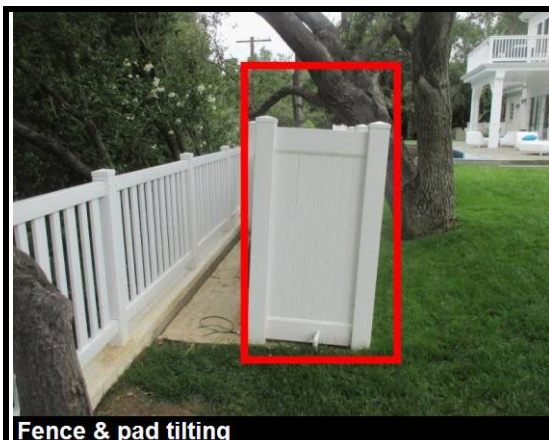
Concrete pad which pool equipment rests on has settled approximately >1" along 1 side. This may stress plumbing pipes. Pad should be underpinned along west edge to prevent further movement. Pool installer should review to verify piping has not been affected.

Fence & pad tilting
