PROPERTY INSPECTION REPORT

**Commercial building
XXXXXX
Glendale, California**

Thursday February 25, 2016

Preferred Home Inspection, LLC

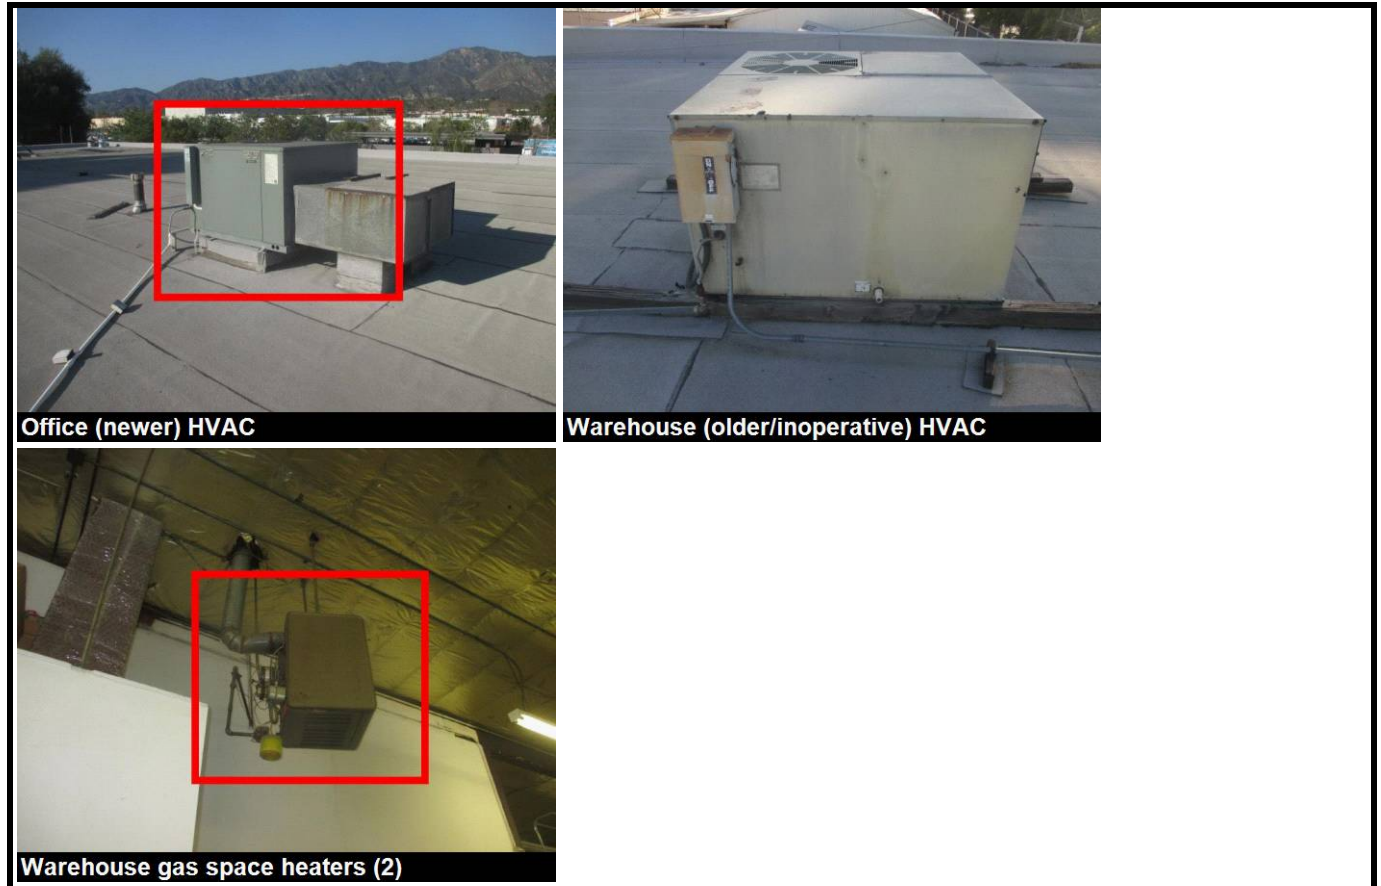
b. HVAC 2 (heating and cooling): Air conditioning and heating systems includes one 5 Ton of roof pack HVAC (central electric refrigerator air and gas forced air furnace) which serves warehouse. Unit age is 1986. System is not operational. Thermostatic control is missing. System is older and showing wear. System may need replacing, though an HVAC service should evaluate to determine if unit can be restored.

c. Other heating: 2 gas space heaters exist at warehouse. Units are original 1968. Units were not operational. System are older and showing wear. System may need replacing, though an HVAC service should evaluate to determine if units can be restored. (Gas space heaters are in addition to central heating. Both heating / cooling systems at warehouse are non-functional.)

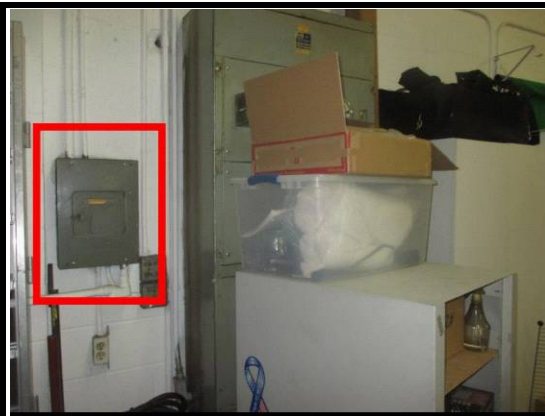
Federal-Pacific panel 1

- a. 3 electrical sub panels (1 at rear of building and 2 small panels at front of building) are Federal-Pacific brand. Electrical professionals conventionally recommended upgrading FPE panels due to certain safety concerns / issues historically associated with this brand. Upgrade should be considered as a precautionary measure and/or be aware of this consensus. Replacement of Federal-Pacific panels is recommended.
- b. Electrical panel circuit directories have incomplete or no labeling. Completing labeling at all panels is recommended for safety and ease of circuit identification.
- c. Front covers is missing knock outs, creating openings in panel fronts at several electrical panels. Plugs / caps should be installed to seal openings. (Minor task)

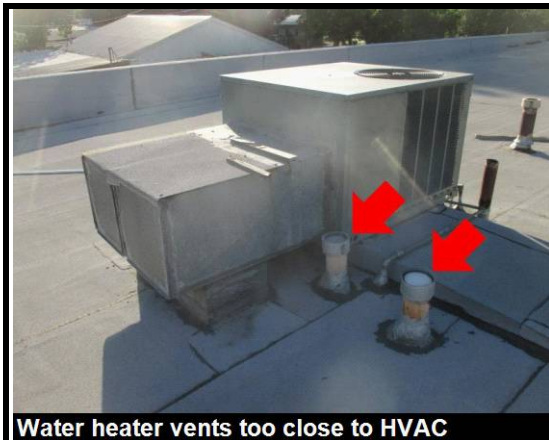
Water heater vent pipes above roof are too low / too close to HVAC unit which may adversely affect venting. Vent pipes should be / need to be extended 12"+ above adjoining HVAC unit.

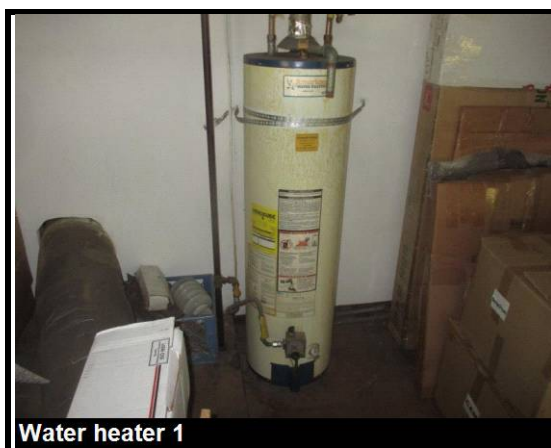
Water heater 1

2 water heaters exist. 1 serves kitchen and ladies' restroom. 1 serves warehouse sink and men's restroom. Water heater is shut off which serves men's restroom and adjoining warehouse sink. Unit could not be lit. This should be further investigated. Both water heaters are 1994. The average life for a standard gas water heater is 12 to 15 years. Replacing units is recommended due to age, prior to leakage occurring. (Consolidating to 1 water heater is suggested.)

Water heater earthquake strapping does not meet current installation standards. Upgrading of strapping is required, prior to close of escrow. (Both water heaters)

Water heater temperature / pressure relief valves have no overflow drains. Drain (s) to exterior which aims downward and terminates 6" from ground or other approved receptor is required. (Both water heaters)

Water heaters have no overflow catch pans. Overflow pans prevent damage to building materials in the event of leakage. While not retroactively mandatory, addition of overflow pans a recommended upgrade.(Both water heaters)

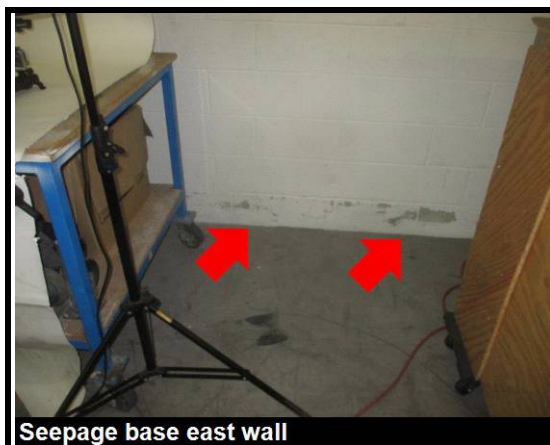
Seepage base east wall

Minor moisture seepage is evident along base of exterior wall at east side of warehouse. Moisture from exterior planter is evidently infiltrating base of wall. Waterproofing base of wall on exterior where soil meets building and applying Dri-lock waterproofing base of wall on interior is recommended to prevent seepage. If electrical is to be installed along base of wall (as indicated), steps should be taken to prevent seepage and provide insulator between electrical and wall.

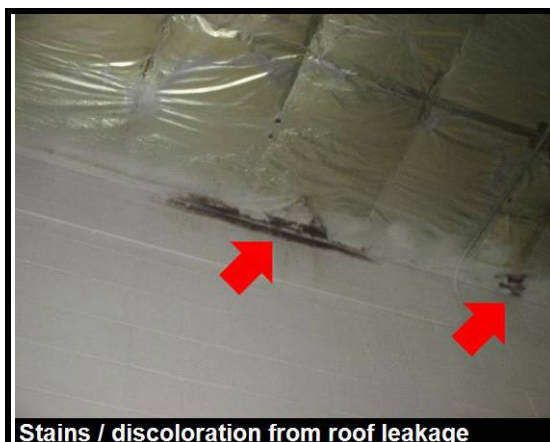
Evidence of effects of roof leakage exists along east most edge of warehouse ceiling. Roof leakage aside, areas of ledger board connects to building side wall have dark appearance which may have a mold component or wood decay. Areas noted were observed from ground level. The areas should be accessed for closer inspection to

determine if any mold or wood decay conditions exist. A Phase 1 environmental inspection is reportedly scheduled. Refer to environmental inspector for evaluation. Termite inspector should evaluate for wood decay.

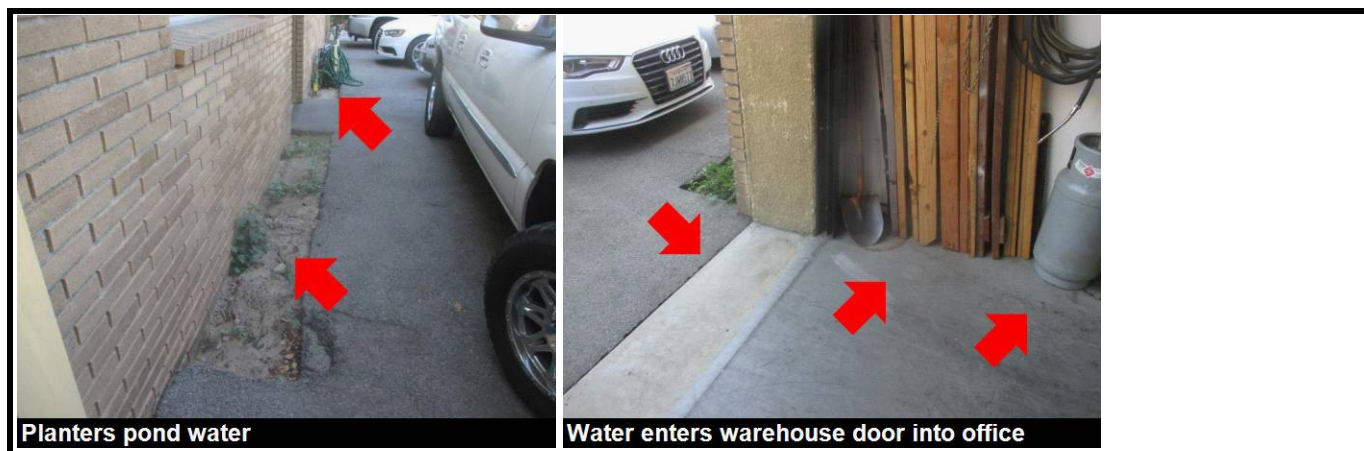
Driveway has 1 drain at front west corner. Driveway has poor drainage adjoining front of building. 2 planters at front have no means of drainage and collect water. There is evidence water intrusion occurs at warehouse overhead door. Visible evidence of water intrusion exists that office which directly adjoins overhead door. Drainage improvement is needed directly along front of building.

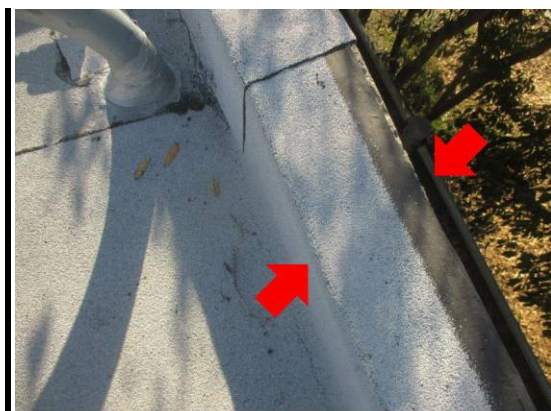
b. Roof perimeter has an elevated parapet wall. Parapet walls require a coping flashing which caps top of parapet. Do you coping flashing is not installed which can, has and may be allow leakage around roof perimeter. Perimeter coping flashing needs to be installed. (Priority)

**Missing coping flashing (cap) perimeter**

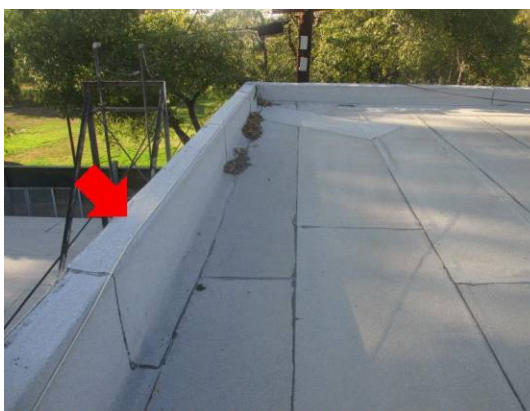
**Missing coping flashing entire perimeter**
