PROPERTY INSPECTION REPORT

**Commercial building
XXXXXX
Glendale, California**

Thursday February 25, 2016

Preferred Home Inspection, LLC

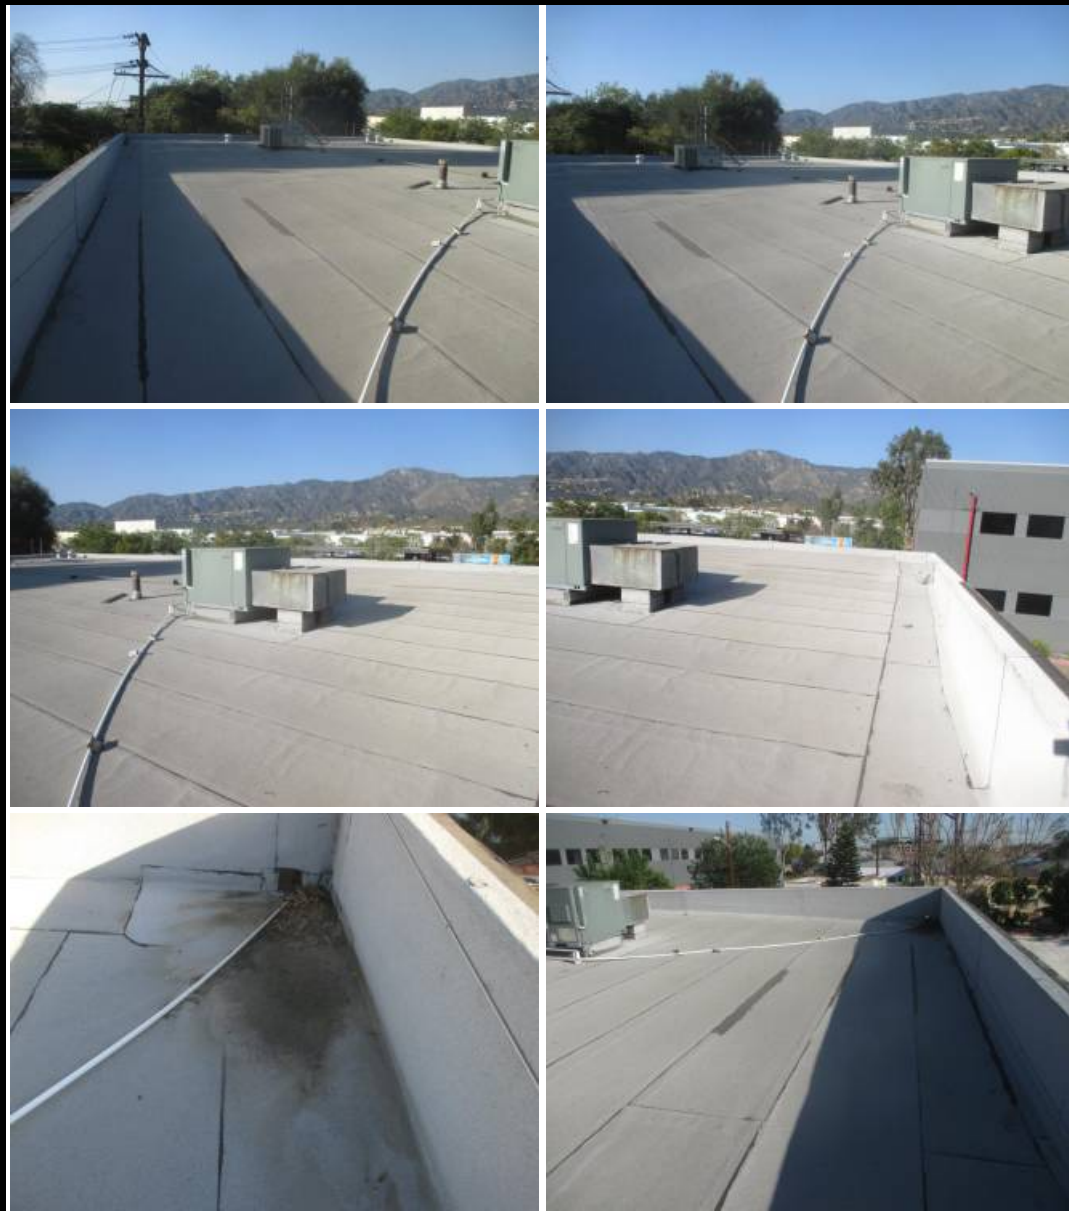
14.5 PHOTOS

Gas piping across roof to heating systems is under strapped / under supported. Piping is required to be and should be strapped/ supported at max. 6' intervals and within 12" of piping termination.

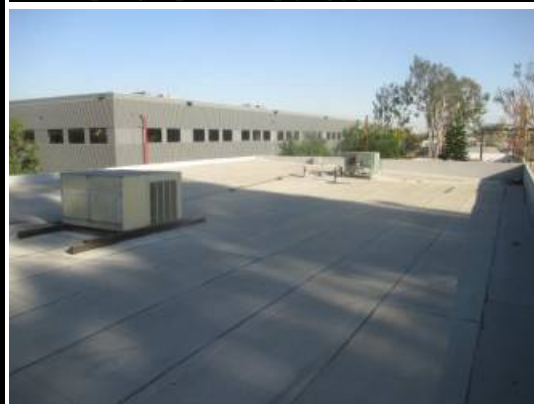
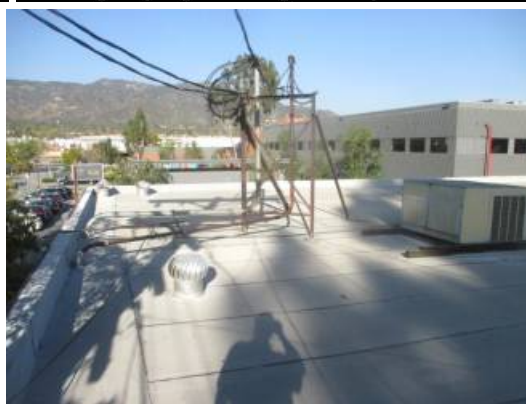
**Missing coping flashing entire perimeter**
